Office of Pest Management

WOOD-DESTROYING INSECT INSPECTION REPORT

1A. VA/HUD/FHA CASE #	DATE OF INSPECTION 6/19/2013
1B. <input checked="" type="checkbox"/> ORIGINAL REPORT <input type="checkbox"/> SUPPLEMENTAL REPORT	1D. WDIIR # 13-479
1C. PURPOSE OF REPORT <input checked="" type="checkbox"/> Sale <input type="checkbox"/> Refinancing <input type="checkbox"/> Other	1E. TARF #

3A. NAME OF INSPECTION COMPANY Alternative Pest & Termite Control LLC	5A. NAME OF PROPERTY OWNER/SELLER Sample
3B. ADDRESS OF INSPECTION COMPANY (Street, City, ZIP) P O Box 1865 Cottonwood AZ 86326	5B. PROPERTY ADDRESS (Street, City, ZIP) 340 Ranch Sedona AZ 86336
3C. TELEPHONE NUMBER (Include Area Code) Office: (928) 567-7332	4. BUSINESS LICENSE # 8437
6A. INSPECTED STRUCTURES House Crawl/ Slab Garage Slab	
6B. LIST ALL UN-INSPECTED STRUCTURES NONE	
7. THIS INSPECTION DOES NOT INCLUDE THE FOLLOWING LISTED AREAS WHICH ARE OBSTRUCTED OR INACCESSIBLE. (See also Item 19, page 2) <u>Attic Joist Wall interiors</u>

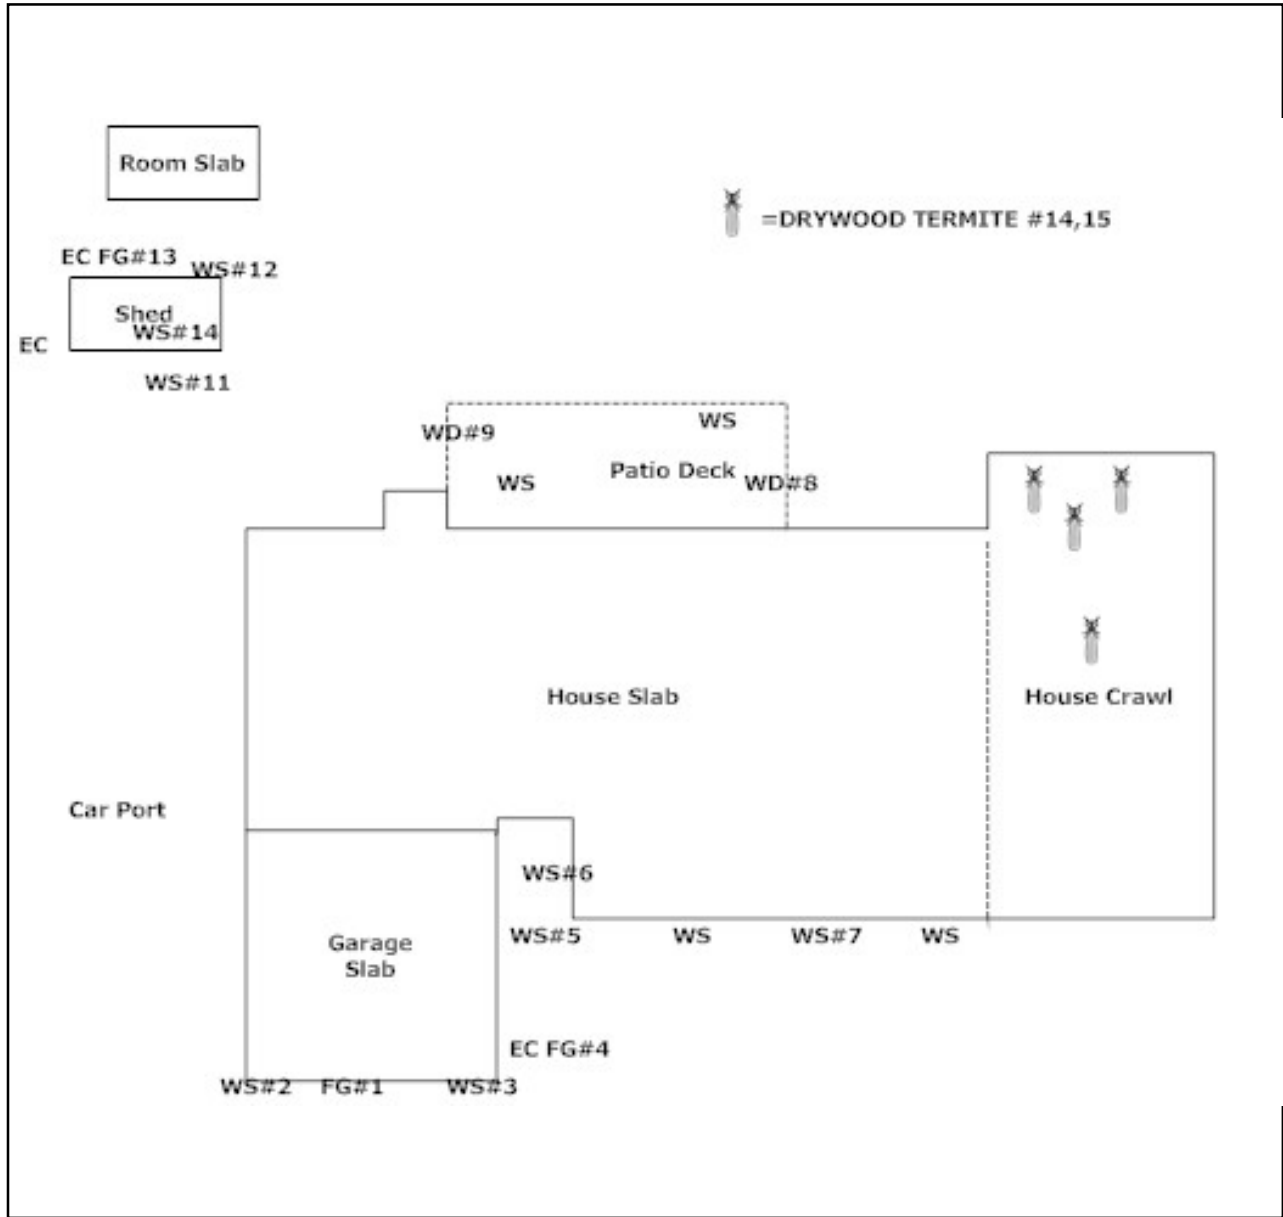
GRAPH OF STRUCTURE(S)

FINDING:(WS) Water stains noted on ceiling of Shed also on wood siding and fascia's also under patio. See Graph and Photo # 2,3,5,6,11,13

FINDING: (FG) (EC) Wood siding below grade. See Graph & Photo # 4,13

FINDING: (FG) Planter against home above floor level: See Graph and Photo #1

FINDING: (WD) Water Damage to the wood patio. Bio Organic Growth found See Graph and Photo # 8,9 RECOMMEND: That damaged wood be removed or cut back to clean wood to correct this conditions small amounts of damaged wood may re infest the new wood in the future

RECOMMEND: The soil be pulled away from the siding to expose the foundation

Recommend this be evaluated by a home inspector as whether this is a condition for moisture problems no moisture condition found on inside wall at time of this inspection
