Office of Pest Management

WOOD-DESTROYING INSECT INSPECTION REPORT

1A. VA/HUD/FHA CASE #	DATE OF INSPECTION 6/19/2013
1B. <input checked="" type="checkbox"/> ORIGINAL REPORT <input type="checkbox"/> SUPPLEMENTAL REPORT	1D. WDIIR # 13-479
1C. PURPOSE OF REPORT <input checked="" type="checkbox"/> Sale <input type="checkbox"/> Refinancing <input type="checkbox"/> Other	1E. TARF #

3A. NAME OF INSPECTION COMPANY Alternative Pest & Termite Control LLC	5A. NAME OF PROPERTY OWNER/SELLER Sample
3B. ADDRESS OF INSPECTION COMPANY (Street, City, ZIP) P O Box 1865 Cottonwood AZ 86326	5B. PROPERTY ADDRESS (Street, City, ZIP) 340 Ranch Sedona AZ 86336
3C. TELEPHONE NUMBER (Include Area Code) Office: (928) 567-7332	4. BUSINESS LICENSE # 8437
6A. INSPECTED STRUCTURES House Crawl/ Slab Garage Slab	
6B. LIST ALL UN-INSPECTED STRUCTURES NONE	
7. THIS INSPECTION DOES NOT INCLUDE THE FOLLOWING LISTED AREAS WHICH ARE OBSTRUCTED OR INACCESSIBLE. (See also Item 19, page 2) <u>Attic Joist Wall interiors</u>

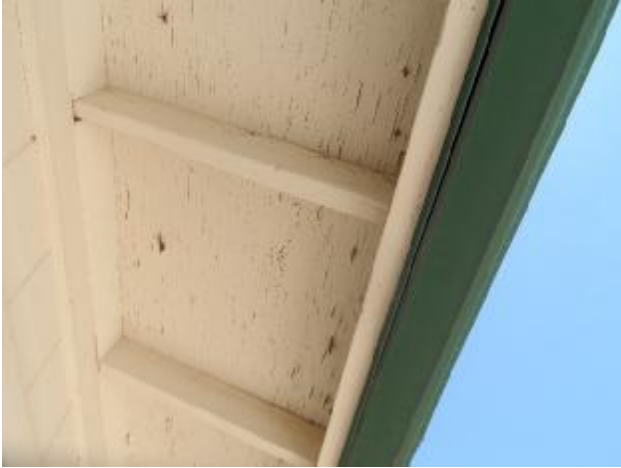
#6

FINDING:(WS) Water stains noted on ceiling of Shed also on wood siding and fascia's also under patio. See Graph and Photo # 2,3,5,6,11,13
